ENHANCEMENT OF DOD RELATED RESEARCH THROUGH ACQUISITION
OF IMPACT TESTIGN EQUIPMENT

**DURIP-97 ENHANCEMENT OF DOD RELATED RESEARCH THROUGH
ACQUISITION OF IMPACT TESTING EQUIPMENT.**

Samuel Ibekwe, Ph.D. – Project Director/Principal Investigator

Mechanical Engineering Department
Southern University
Baton Rouge, Louisiana 70813

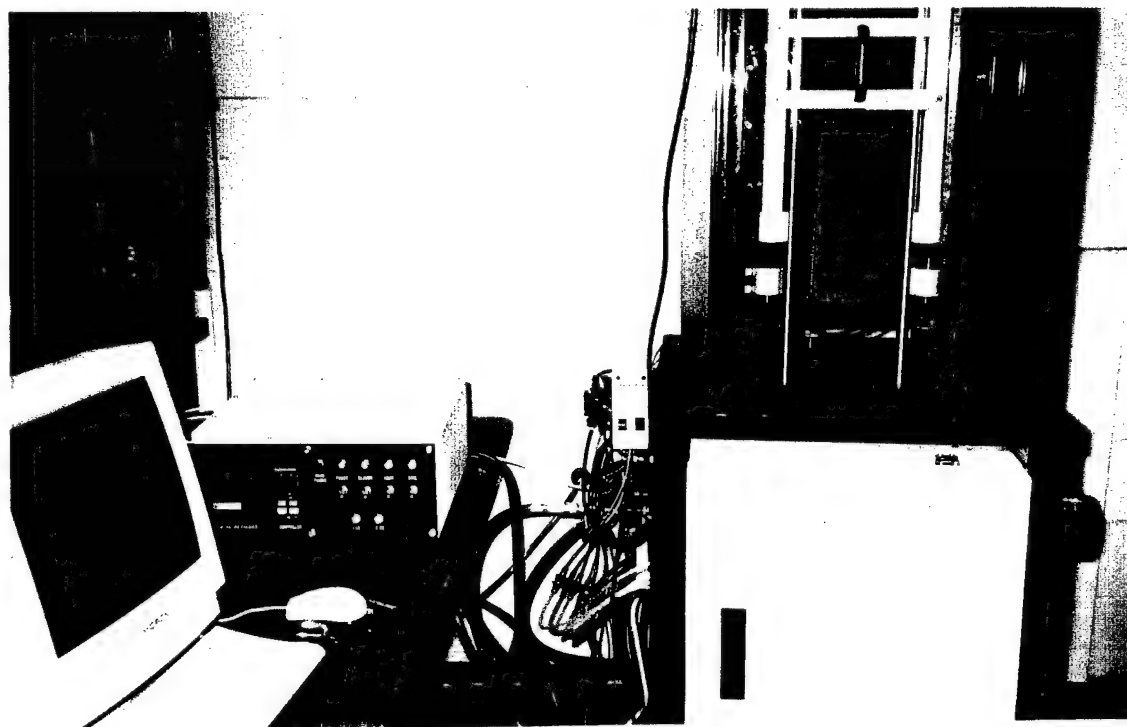
Figure 4. Connected Personal Computer and Data Acquisition system to Impact Testing equipment.

Complete installation of the above equipment and accessories was completed on Wednesday, January 14, 1998 by Mr. David Smith of Instron company. Figures 1 through 5 respectively show the installed equipment. The institution provided the requisite infrastructure as well as space and technical support towards the successful installation.
